Manhole Inspection Summary

Manhole # S65E__010MH

Insp Date: **3/14/08 1:16 PM**

Location Address: **302 Drew St.**

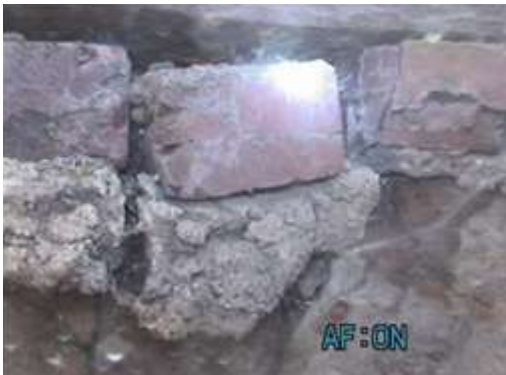
Defect 2

Condition: ☐ Sound ☐ Cracked ☐ Root Intrusion ☒ **Loose Brick** ☒ **Deteriorated**

Loose bricks with sign of deterioration,

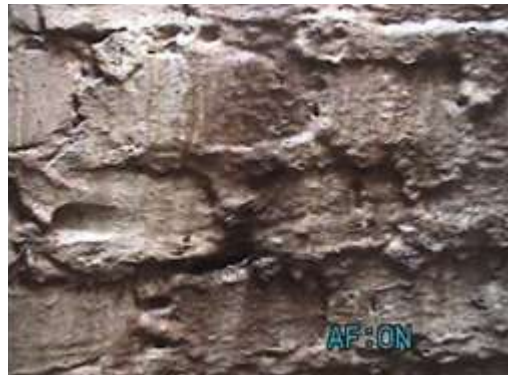
Defect 1

Infiltration: ☐ None ☒ **Joint** ☐ Cracks ☒ **Mortar** ☐ Roots ☐ Wall

Signs of infiltration

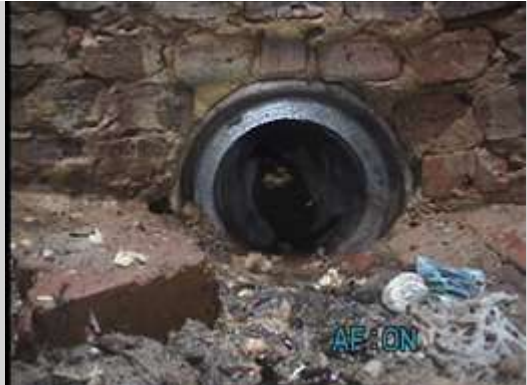
12 O'Clock Outflow

8 in. Circular Gravity Sewer
Pipe Out @ 12 O'Clock

Deposits: ☐ None ☐ Mud ☐ Sludge ☒ **Debris** ☐ Grease

Silt Depth: **0.25** (in.) Deposits Extent: **Light**
